**NATATORIUM REIMAGINATION AND REDEVELOPMENT**

**ADDENDUM NO. 1**

CITY OF ROLLA  
THE CENTRE - Natatorium Planning Study

# NATATORIUM FACILITY ASSESSMENTS - ARCHITECTURAL AND AQUATICS

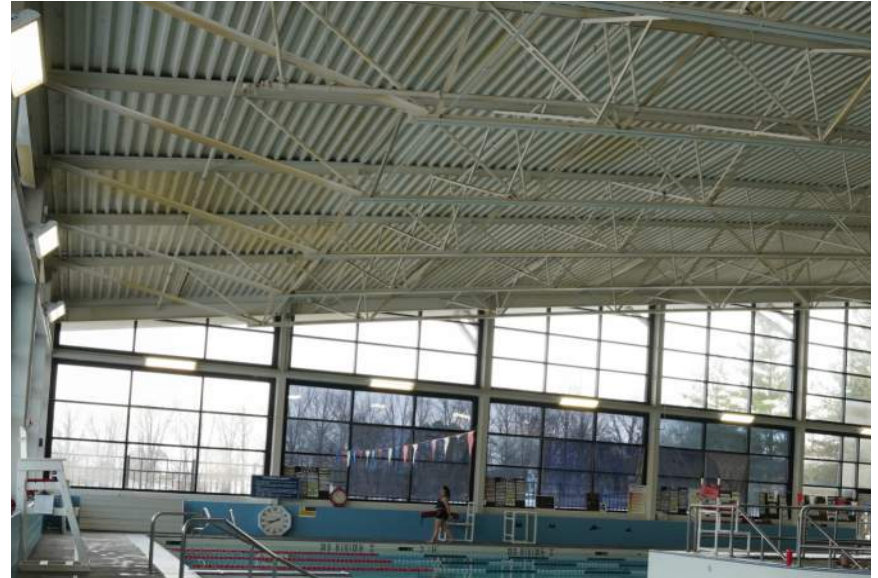
- The natatorium ceiling/roof structure is made up of 64" deep long-span steel roof trusses spaced at 5'-0" on center supporting corrugated metal decking
- The existing exposed roof structure (metal deck and steel trusses) is yellowing and showing indications of rust throughout. This includes horizontal steel support beams above the exterior window walls.
- The yellowing and unsightly appearance is the result of older paint reacting to the pool chemicals and UV light. The rust is a result of bare steel being exposed to moisture and harsh pool chemicals over time.
- Staff noted that the roof is currently leaking with water infiltrating the interior at various locations adjacent to the east exterior wall.

Discoloration of painted steel metal decking

- Sand blast and repair the entire metal roof structure including metal decking, bar joists and other exposed steel members.
- Inspect roof for potential leaking and undertake efforts to mitigate water infiltration into the natatorium feature.

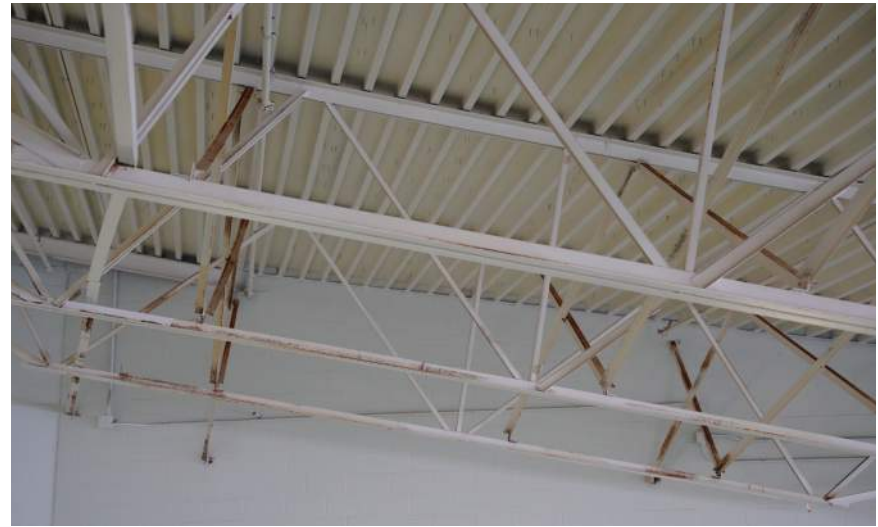
- The existing metal deck and steel truss exposed roof structure is yellowing and showing indications of rust throughout. This includes horizontal steel support beams above the exterior window walls. The yellowing material is the result of older paint reacting to the pool chemicals and UV light. The rust is a results of the metal becoming exposed to the moisture and harsh pool chemicals.

Rust on steel roof trusses

- HVAC - Remove and replace the existing, ageing pool HVAC / dehumidification equipment.
- Exposed Roof Structure - Recondition the metal deck, steel roof trusses and steel beams. Remove all compromised paint finish and rust and repaint in its entirety with an industrial grade paint system.

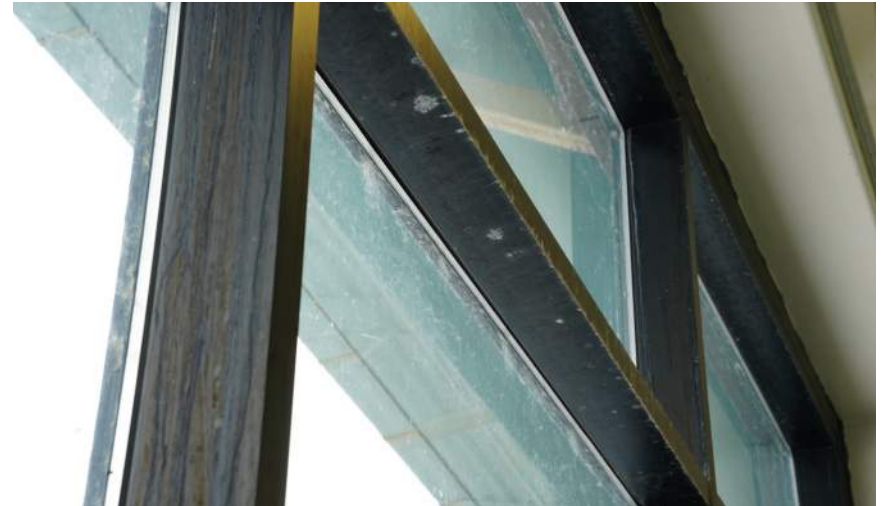
- Anodized aluminum and glass window system is still in relatively good condition. Some streaking is visible in various locations of the aluminum frames
- Glazing also appears to be in good condition, with only minor streaking / etching observed in a few locations.
- The air curtain fed from the sill of the exterior glass wall is intended to prevent or greatly reduce condensation on the exterior glazing and appears to be working as designed.
- Steel framing above the exterior aluminum window wall system is showing signs of rusting in isolated areas. This is likely, in part from moisture infiltration previously noted and leaking along the east elevation.

Minor staining of anodized aluminum frame system

- Thoroughly inspect exterior window wall system.
- Clean windows and anodized aluminum frame system after leaking has been resolved.

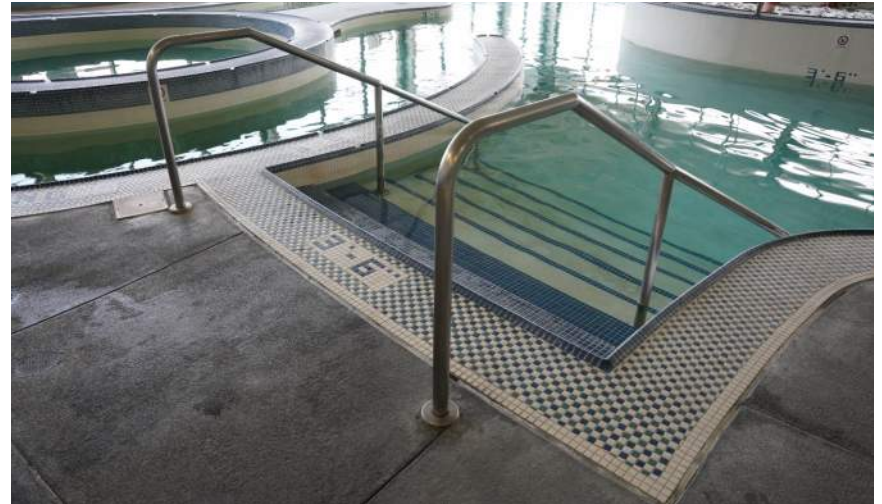
- The broom finished concrete deck appears to be in relatively good condition for its age.
- Multiple cracks were observed in the concrete deck in the northeast corner of the natatorium and along the east elevation
- Concrete control joints and expansion joints have been caulked in many areas
- The caulk joint between the perimeter pool tile band and the concrete deck is overall in good condition. However, several areas where caulk is missing or has failed were observed.

Expansion joint between colored concrete pool deck at perimeter pool tile band

- Patch any exposed concrete cracks in the pool deck
- Re-caulk expansion joints throughout the concrete pool deck and at the expansion joint between the colored concrete deck and the pool tile edge band

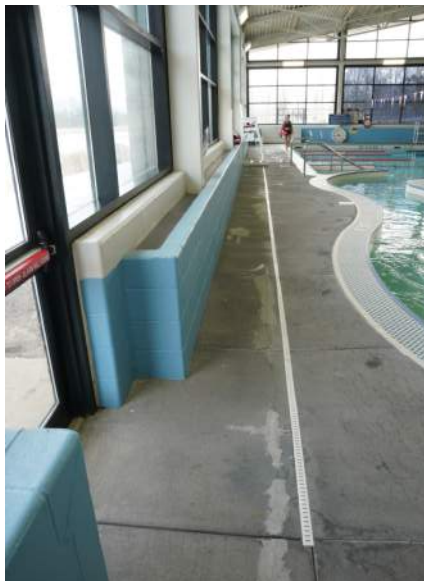
Cracks in colored concrete pool deck

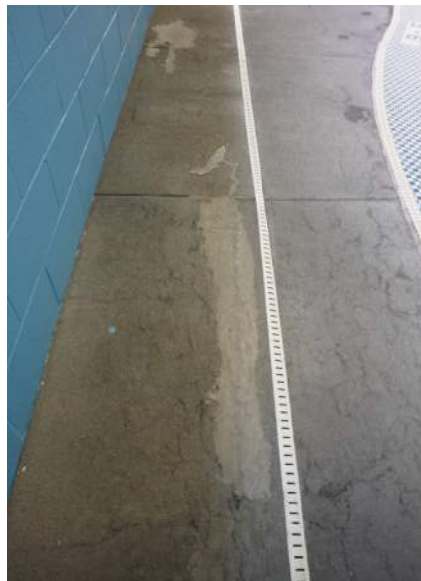
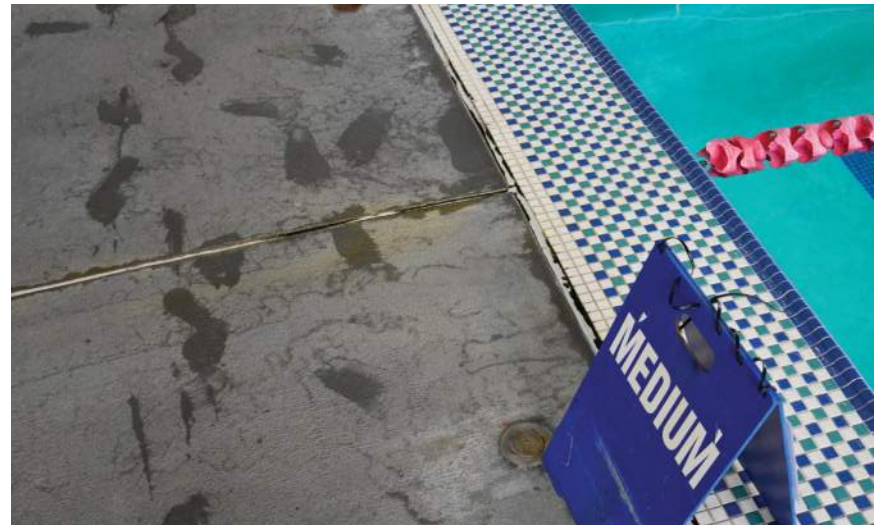
Failing expansion joint caulking

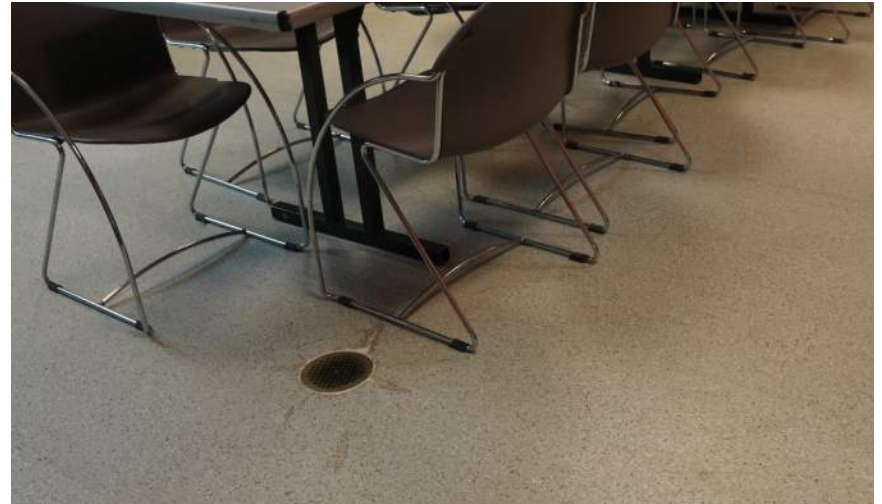
- Overall condition of the space is very good for it's age.
- Ceiling is still in fairly good condition with visible signs of wear and dirt and a few damaged tiles.
- The slip resistant sheet vinyl flooring has held up remarkably well for its age. Cracking was observed around the internal floor drain and minor portions of seams are showing signs of deterioration.
- Minor patching is visible around the floor at the drain.
- The interior aluminum and glass entry, the interior steel doors and door frames and the exterior window and glazing are all in good condition.

Patching of vinyl flooring at floor drain

- Inspect above ceiling for signs of corrosion on existing steel structure
- A few ceiling tiles should be replaced at a minimum
- Patch or replace slip resistant vinyl sheet flooring.

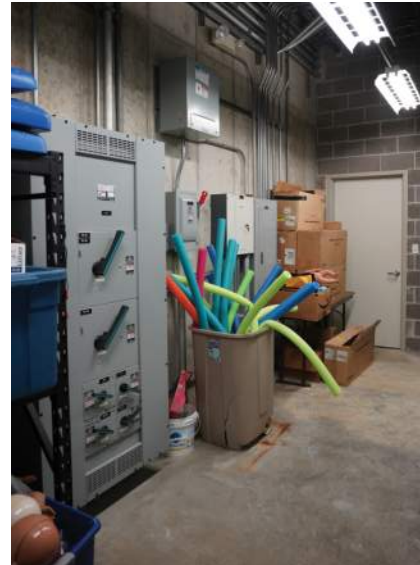
- Room and electrical panels appear to be in very good condition.
- Room is doubling as pool storage which is not uncommon.

Electrical Switchgear / storage items

- Check electrical panel wiring connections for any signs of corrosion.
- Move pool equipment and supplies to a dedicated storage room

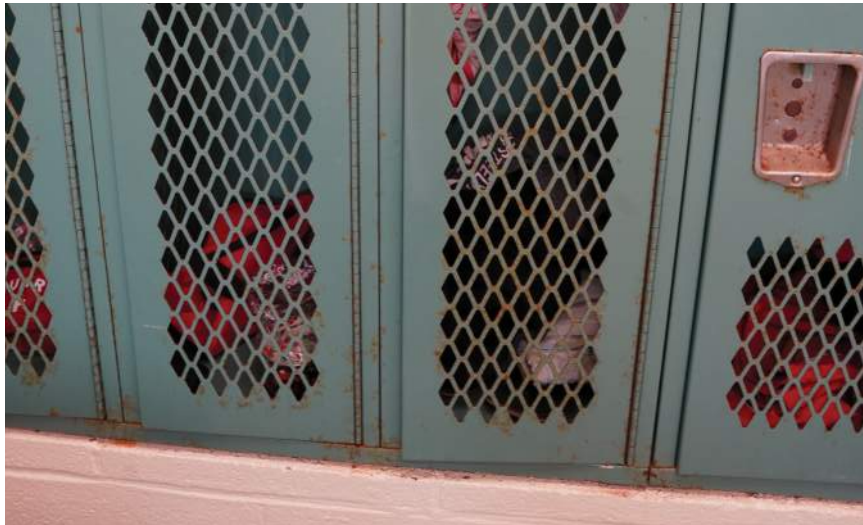
- Rusting is visible on metal lockers
- Floor appears to be in relatively good condition aside from a few observable cracks around the floor drain.

Prefinished metal locker with signs of rusting

- Closer inspection to check for flooring / ceiling issues
- Inspect area above ceiling for signs of degradation from pool chemicals
- Patch slip resistant vinyl flooring, or replace with new
- Lockers have far exceeded their expected life span in an indoor pool environment. Replace prefinished metal lockers with phenolic resin lockers.

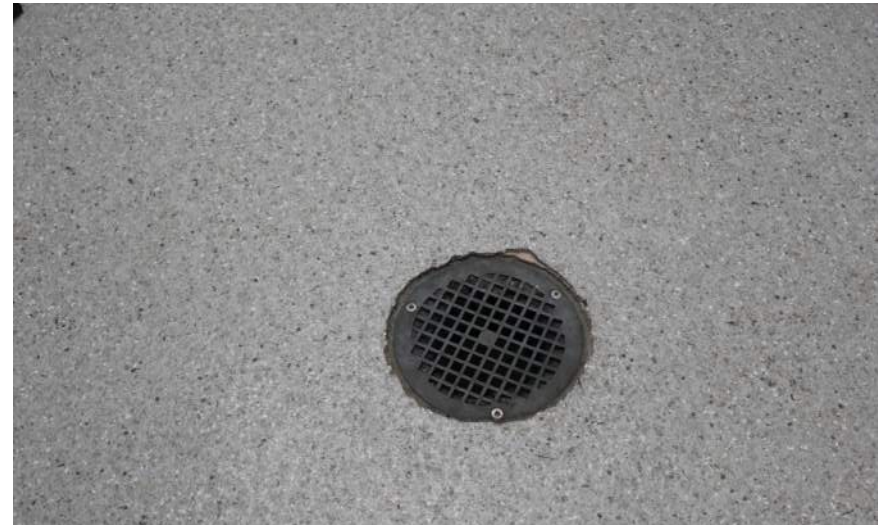
Slip resistant vinyl floor at floor drain

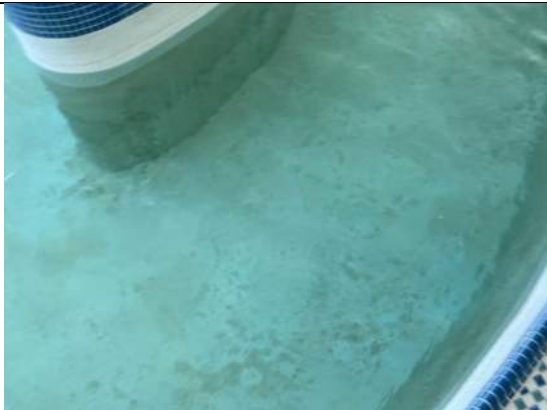
The pool interior plaster finish is in poor condition and exhibits widespread delamination, staining, spider cracking, and exposed concrete. Multiple areas of patch repair were observed, including repairs on one of the entry stairs. These stairs also had large exposed areas of concrete. Rebar bleed-through was also observed on lap lane wall surfaces and in the current channel.

Figure 7 Plaster staining and discoloration

- Replaster the entire main pool to address delamination, cracking, exposed concrete, and staining.
- Replaster therapy pool surfaces, including steps, benches, and interior walls.
- Replace missing or damaged tile and regrout the perimeter.
- Replace popped or loose tile at underwater bench seating.
- Replace the original shallow area children's feature.
- Inspect stainless steel railings and anchors and implement ongoing maintenance schedule.

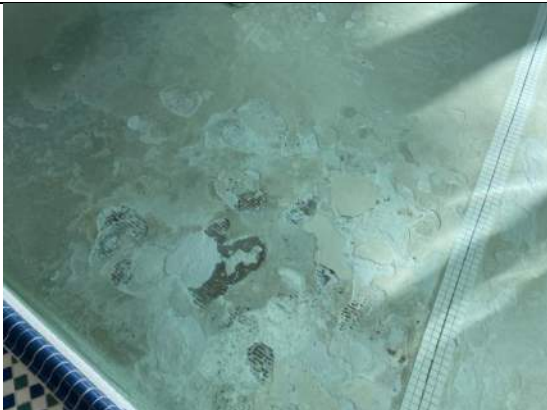
Figure 8 Plaster delamination

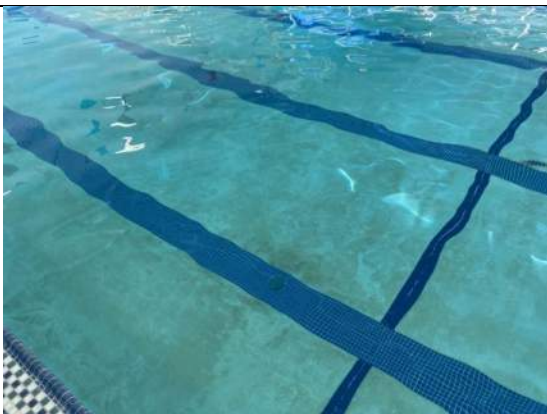
Figure 10 Plaster staining in lap lanes

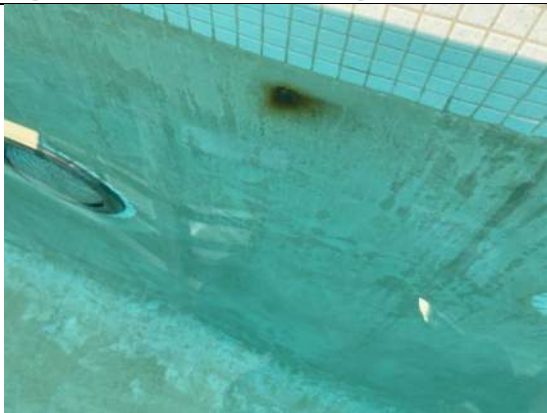
Figure 11 Rebar bleed through

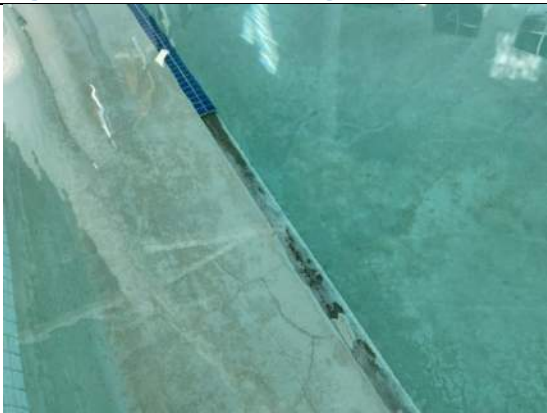
Pool tile in portions of the current channel was observed to be in good condition with no major cracking or popping. However, other tile areas show buildup, missing pieces, and failing grout specifically popped tile was observed at the underwater bench seat in the shallow area. Perimeter tile exhibits notable scale buildup and discoloration.

Figure 12 Missing tile on underwater bench

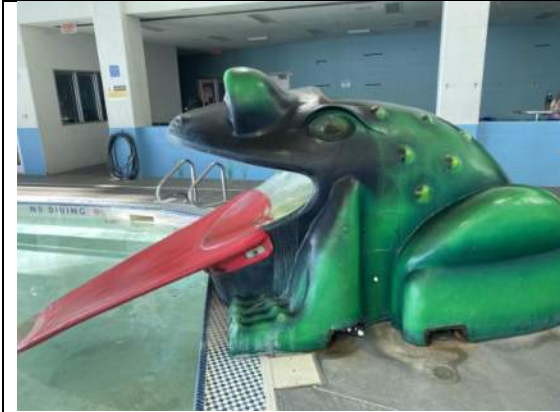
The frog slide in the shallow end shows corrosion at the base. The slide finish is faded and would require surface preparation and repainting if it continues in use. The slide landing pad is in need of replacement.

Figure 13 Frog Slide (Corrosion at base)

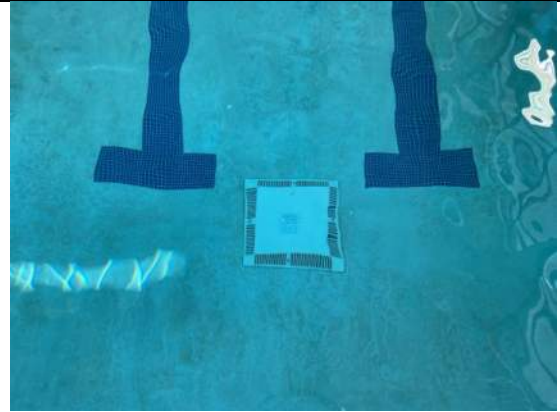
Virginia Graeme Baker Pool and Spa Safety Act (VGBA) main drain grates were noted as installed in 2017 with an estimated 15-year lifecycle as noted on the grates. These should be monitored and scheduled for replacement in accordance with manufacturer recommendations.

Figure 14 Main drain

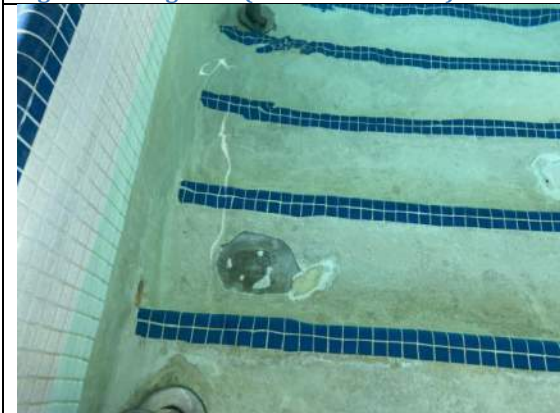
Figure 15 Plaster spalling and delamination on stair entry

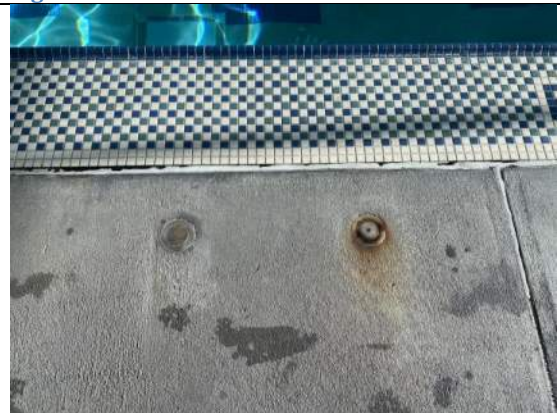
The pool deck exhibits cracking and deterioration. Deck cracking and uneven surfaces present trip hazards and should be corrected. Corrosion was also observed at starting block anchor points. Corrosion was observed on stainless steel railings and other deck-mounted components.

Figure 16 Corrosion on deck anchors

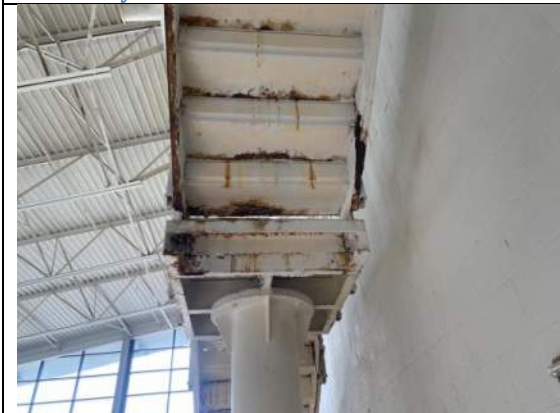
The waterslide tower structure shows heavy corrosion on supports and the underside of the platform. Peeling paint and corrosion were observed throughout the waterslide stairs, including areas of complete deterioration. The waterslide has been closed for two years due to insurance recommendations based on the condition of the stairs and tower. Staff report the waterslide is tested monthly and rust often comes down the slide when turned on.

Figure 17 Waterslide tower corrosion

- Engage a qualified structural engineer to evaluate the waterslide tower and slide support framing for structural integrity.
- Remove the waterslide and/or tower if structural repairs are not feasible or if continued operation is not desired.
- Remove or replace the frog slide and replace the underwater landing pad.
- Replace underwater light fixtures and confirm watertight seals; inspect electrical components.
- Repair exposed reinforcing steel in pool shell and deck areas to prevent further deterioration.
- Repair cracked deck surfaces to remove trip hazards and eliminate sharp edges.

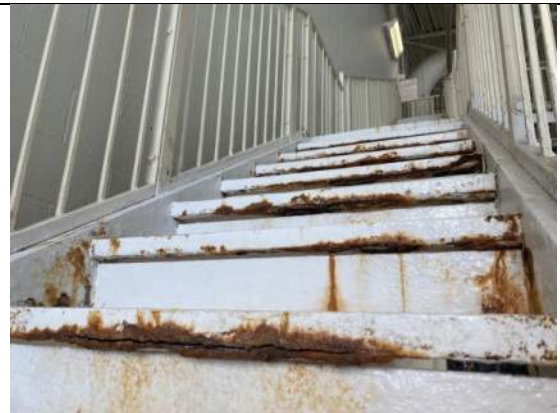
Figure 18 Waterslide tower stair corrosion

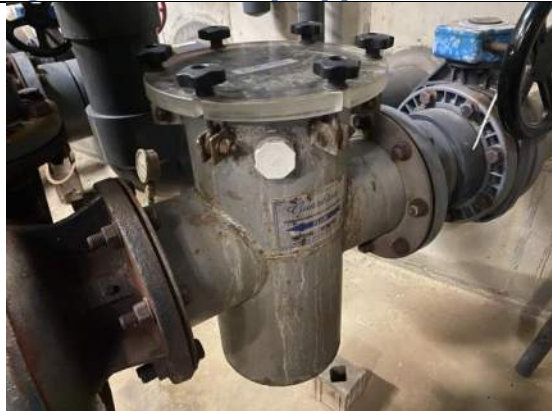
The pool's mechanical and recirculation equipment is primarily original to the pool and has observed corrosion on pumps, motors, pipe hangers, and strainer baskets. The system consists of four Neptune Benson high-rate sand filters which have some rust, corrosion, and leaks. Standing water was present in the pump room because of this. A fifth high-rate sand filter is installed on the recirculation system for the waterslide plunge area that has been converted to a warm-water spa/therapy pool. Flow meters were not functioning. A Lochinvar heater was observed with corrosion on exhaust piping. Electrical cabinets also exhibit corrosion. The chlorine room and acid room were open to the pump room as opposed to being separately ventilated which is the current standard for chemical room design.

Figure 22 Recirculation system components corrosion

- Replace original Neptune Benson high-rate sand filtration.
- Replace corroded pumps, motors, strainers, and valves.
- Replace flow meters.
- Evaluate chemical feed systems and ensure proper containment, ventilation, and code-compliant separation.
- Inspect and replace corroded heater exhaust piping; evaluate heater replacement due to age and condition.
- Upgrade electrical panels that are exhibiting corrosion.
- Verify that UV systems are functional.
- Consider automation upgrades to the pool's mechanical system.
- Evaluate and correct chemical room separation and ventilation.

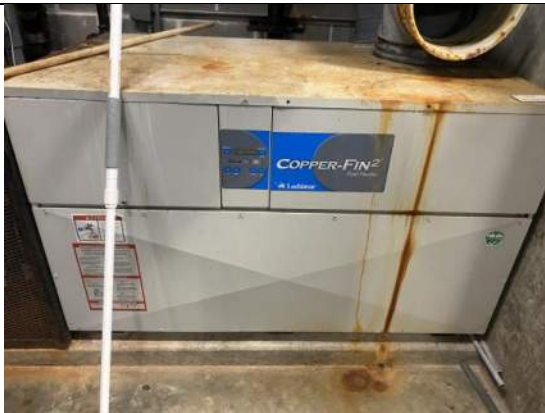
Figure 23 Lochinvar pool heater (corrosion)
