**NATATORIUM REIMAGINATION AND REDEVELOPMENT**

**ADDENDUM NO. 1**

CITY OF ROLLA  
THE CENTRE - Natatorium Planning Study

# NATATORIUM FACILITY ASSESSMENTS - ARCHITECTURAL AND AQUATICS

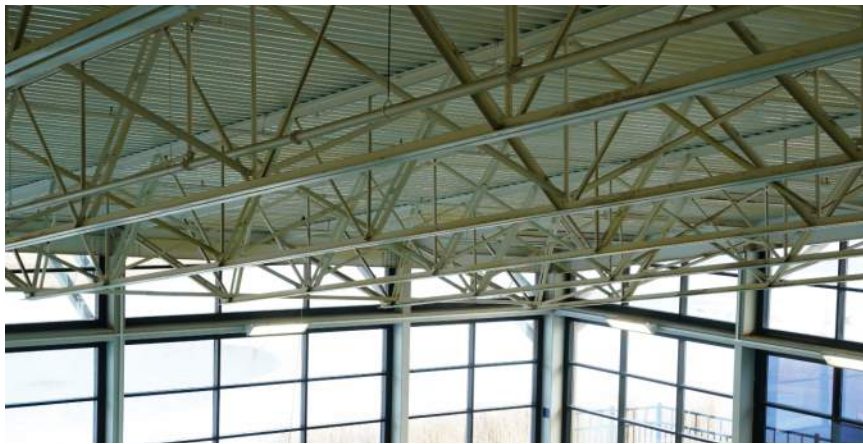
- The existing metal deck and steel truss exposed roof structure is yellowing and showing indications of rust throughout. This includes horizontal steel support beams above the exterior window walls. The yellowing material is the result of older paint reacting to the pool chemicals and UV light. The rust is a results of the metal becoming exposed to the moisture and harsh pool chemicals.

- The natatorium ceiling/roof structure is made up of 64" deep long-span steel roof trusses spaced at 5'-0" on center supporting corrugated metal decking
- The existing exposed roof structure (metal deck and steel trusses) is yellowing and showing indications of rust throughout. This includes horizontal steel support beams above the exterior window walls.
- The yellowing and unsightly appearance is the result of older paint reacting to the pool chemicals and UV light. The rust is a result of bare steel being exposed to moisture and harsh pool chemicals over time.
- Staff noted that the roof is currently leaking with water infiltrating the interior at various locations adjacent to the east exterior wall.

Discoloration on steel roof trusses and metal decking

- HVAC - Remove and replace the existing, ageing pool HVAC / dehumidification equipment.
- Exposed Roof Structure - Recondition the metal deck, steel roof trusses and steel beams. Remove all compromised paint finish and rust and repaint in its entirety with an industrial grade paint system.

- Sand blast and repair the entire metal roof structure including metal decking, bar joists and other exposed steel members.
- Inspect roof for potential leaking and undertake efforts to mitigate water infiltration into the natatorium feature.

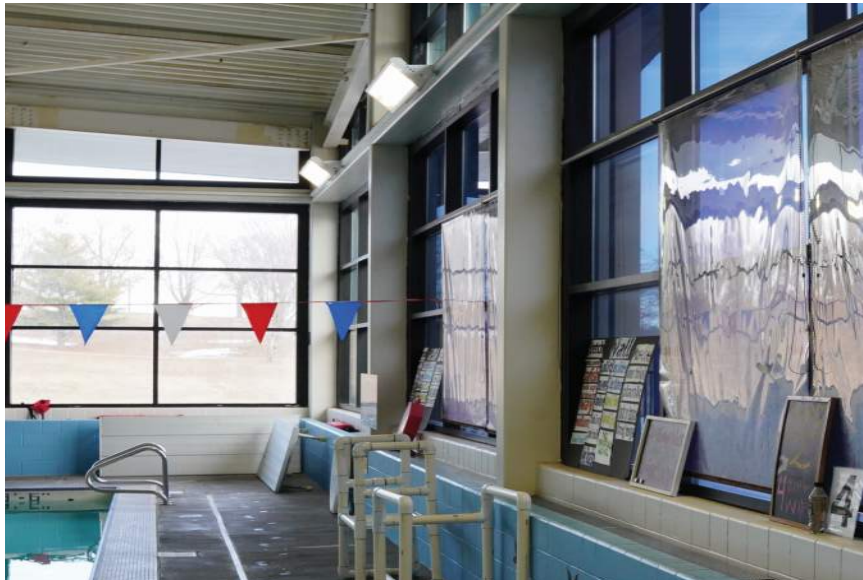
- Anodized aluminum and glass window system is still in relatively good condition. Some streaking is visible in various locations of the aluminum frames
- Glazing also appears to be in good condition, with only minor streaking / etching observed in a few locations.
- The air curtain fed from the sill of the exterior glass wall is intended to prevent or greatly reduce condensation on the exterior glazing and appears to be working as designed.
- Steel framing above the exterior aluminum window wall system is showing signs of rusting in isolated areas. This is likely, in part from moisture infiltration previously noted and leaking along the east elevation.

Exterior window wall

- Thoroughly inspect exterior window wall system.
- Clean windows and anodized aluminum frame system after leaking has been resolved.

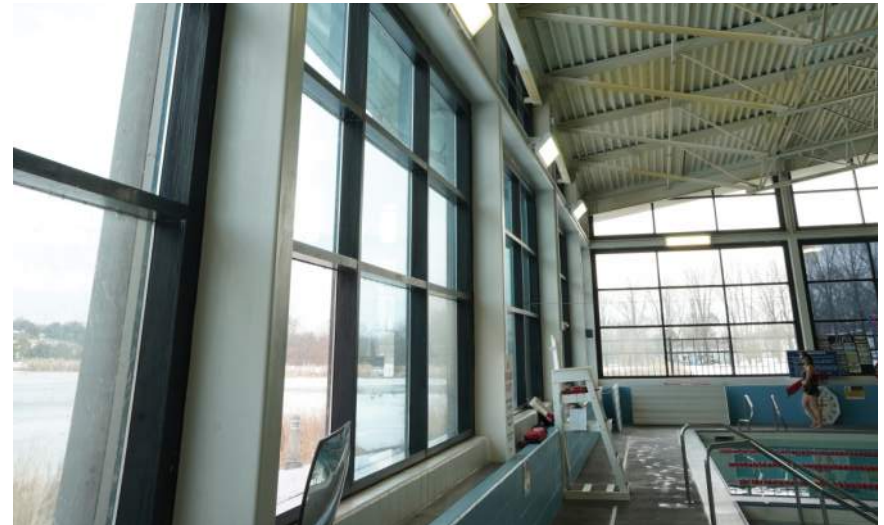
Exterior natatorium glazing and aluminum frame

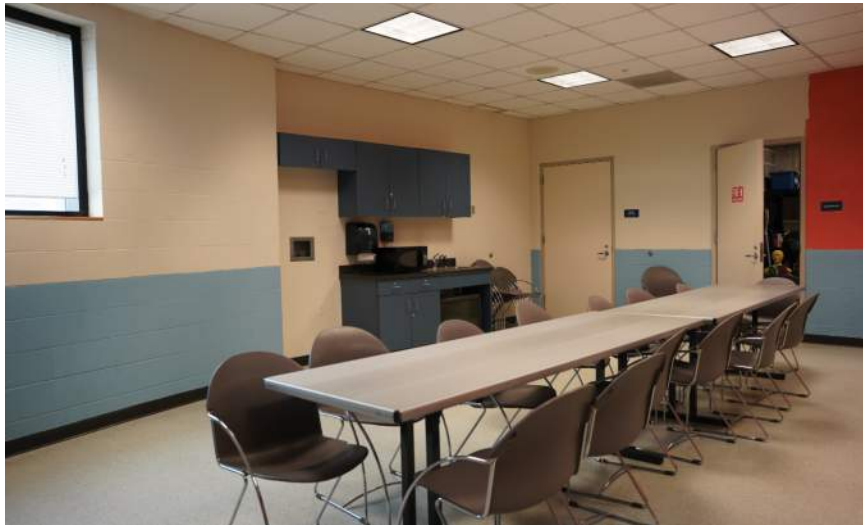
- Overall condition of the space is very good for it's age.
- Ceiling is still in fairly good condition with visible signs of wear and dirt and a few damaged tiles.
- The slip resistant sheet vinyl flooring has held up remarkably well for its age. Cracking was observed around the internal floor drain and minor portions of seams are showing signs of deterioration.
- Minor patching is visible around the floor at the drain.
- The interior aluminum and glass entry, the interior steel doors and door frames and the exterior window and glazing are all in good condition.

Wet Multipurpose Room with open door to electrical equipment room beyond

- Inspect above ceiling for signs of corrosion on existing steel structure
- A few ceiling tiles should be replaced at a minimum
- Patch or replace slip resistant vinyl sheet flooring.

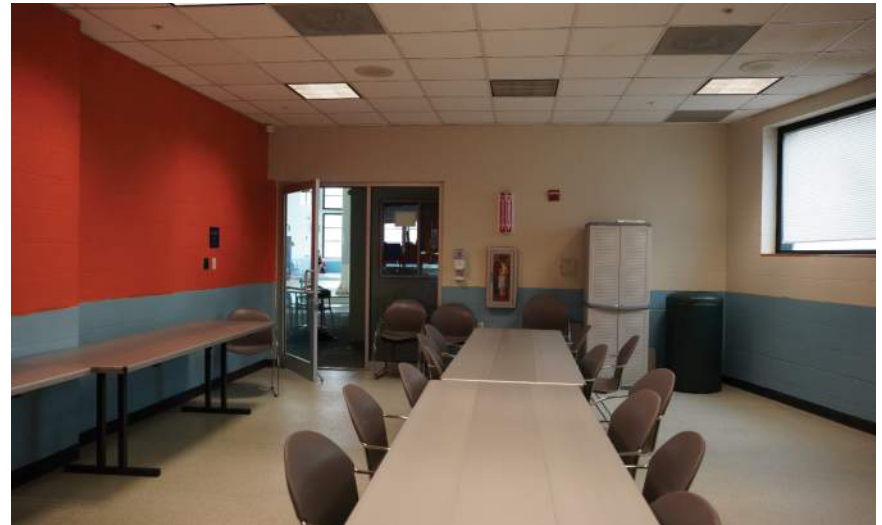
Wet Multipurpose Room view towards natatorium

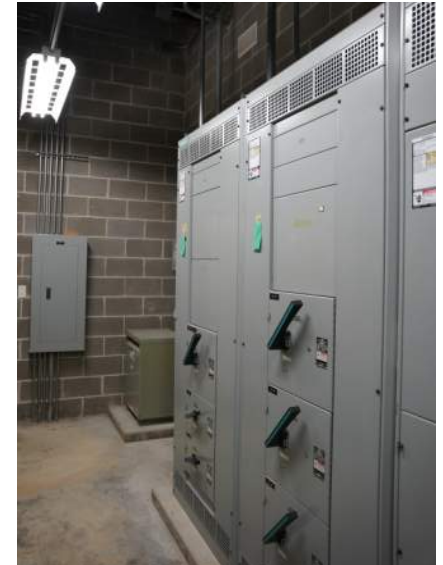
- Room and electrical panels appear to be in very good condition.
- Room is doubling as pool storage which is not uncommon.

Electrical Switchgear

- Check electrical panel wiring connections for any signs of corrosion.
- Move pool equipment and supplies to a dedicated storage room

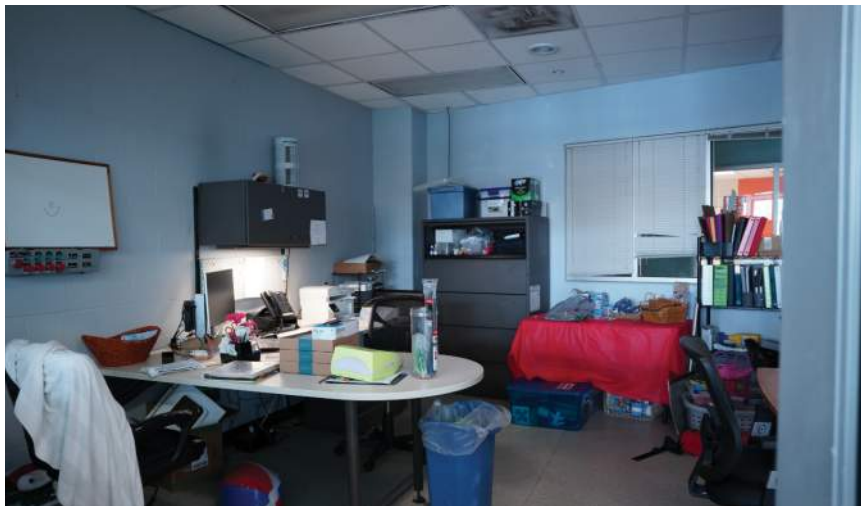
- The Pool Staff office has been well maintained and appears to be in good condition.

Pool Office

- Closer inspection to check for flooring / ceiling Issues
- Inspect above ceiling for signs of corrosion on structure above

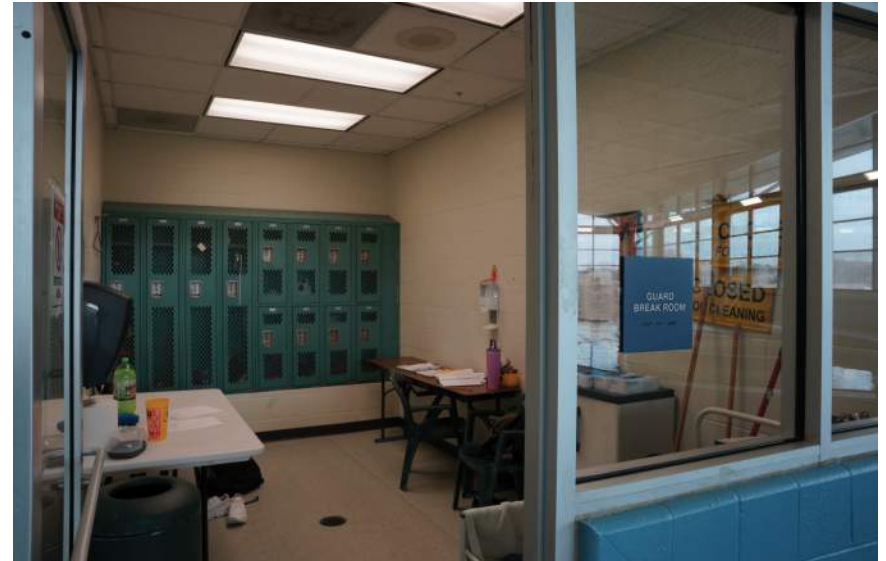
Guard Break Room overview

- Closer inspection to check for flooring / ceiling issues
- Inspect area above ceiling for signs of degradation from pool chemicals
- Patch slip resistant vinyl flooring, or replace with new
- Lockers have far exceeded their expected life span in an indoor pool environment. Replace prefinished metal lockers with phenolic resin lockers.

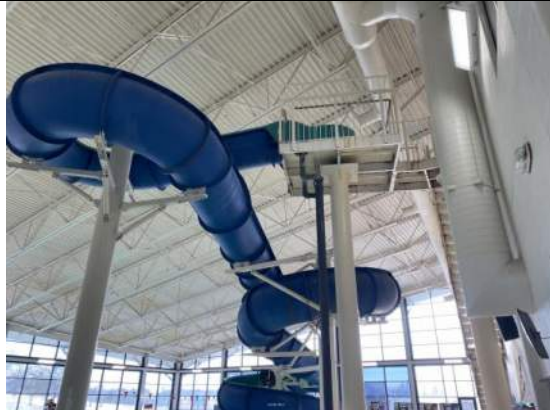
- Waterslide and tower are now dangerous and unsightly relics in the natatorium.
- The Pool Pac equipment (Pool HVAC/dehumidification unit) has exceeded its life span and requires a good deal of maintenance and cost to keep operational.

- Water Slide: The entire structure is now dangerous and unsightly and should be entirely removed. The slide could be replaced if the city desires to keep the feature.

**Figure 4 Waterslide**

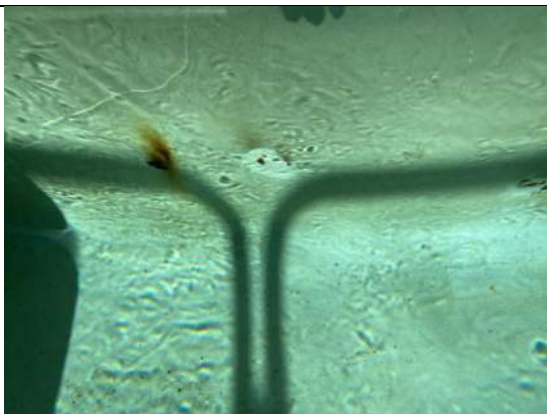
- The existing portland cement plaster finish within the pools has outlived is life span.
- Metal lockers in the Life Guard room have also outlasted their life span and are showing signs of rusting.

Figure 9 Rebar bleed through

- Pool Finish – Remove and replace all existing portland cement plaster and replace with a Quartz aggregate and fortified white Portland cement finishes system. This product has a longer shelf life than Portland cement plaster, requires less maintenance, is easier on bare feet and provides a better aesthetic in the water.
